## Aviation Safety

# Maintainer

Issue 1/2002

## Fatigue and Complacency—A Potentially Sorrowful Mixture

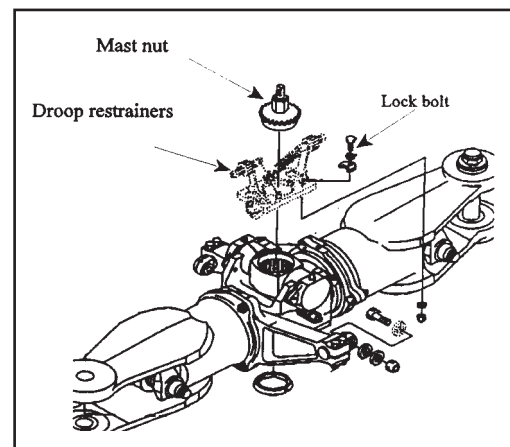
Rotor head.

A brief inquiry disclosed that the aircraft had departed with the main rotor retaining nut assembly missing from the craft. The parts were found on the engineer's worktable where they had been left for drying after being painted. Unfortunately this is not an isolated event! In one form or another, such accidents occur at regular intervals and with similar tragic consequences.

minimum basis to ensure the airworthiness of a flight and should be adhered to rigorously. A logbook entry of the work carried out could have saved the day. The flagging of the controls in the cabin and of the mast of the helicopter would have drawn attention at a critical moment of preflight and would have enforced the fact that critical parts were being serviced.
